**EFFECTS OF ENVIRONMENT ON CREEP BEHAVIOR OF
NEXTEL720/ALUMINA-MULLITE CERAMIC COMPOSITE
WITH $\pm 45^\circ$ FIBER ORIENTATION AT 1200°C
THESIS**

AFIT/GSS/ENY/09-M05

**DEPARTMENT OF THE AIR FORCE
AIR UNIVERSITY**

Degree of Master of Science (Space Systems)

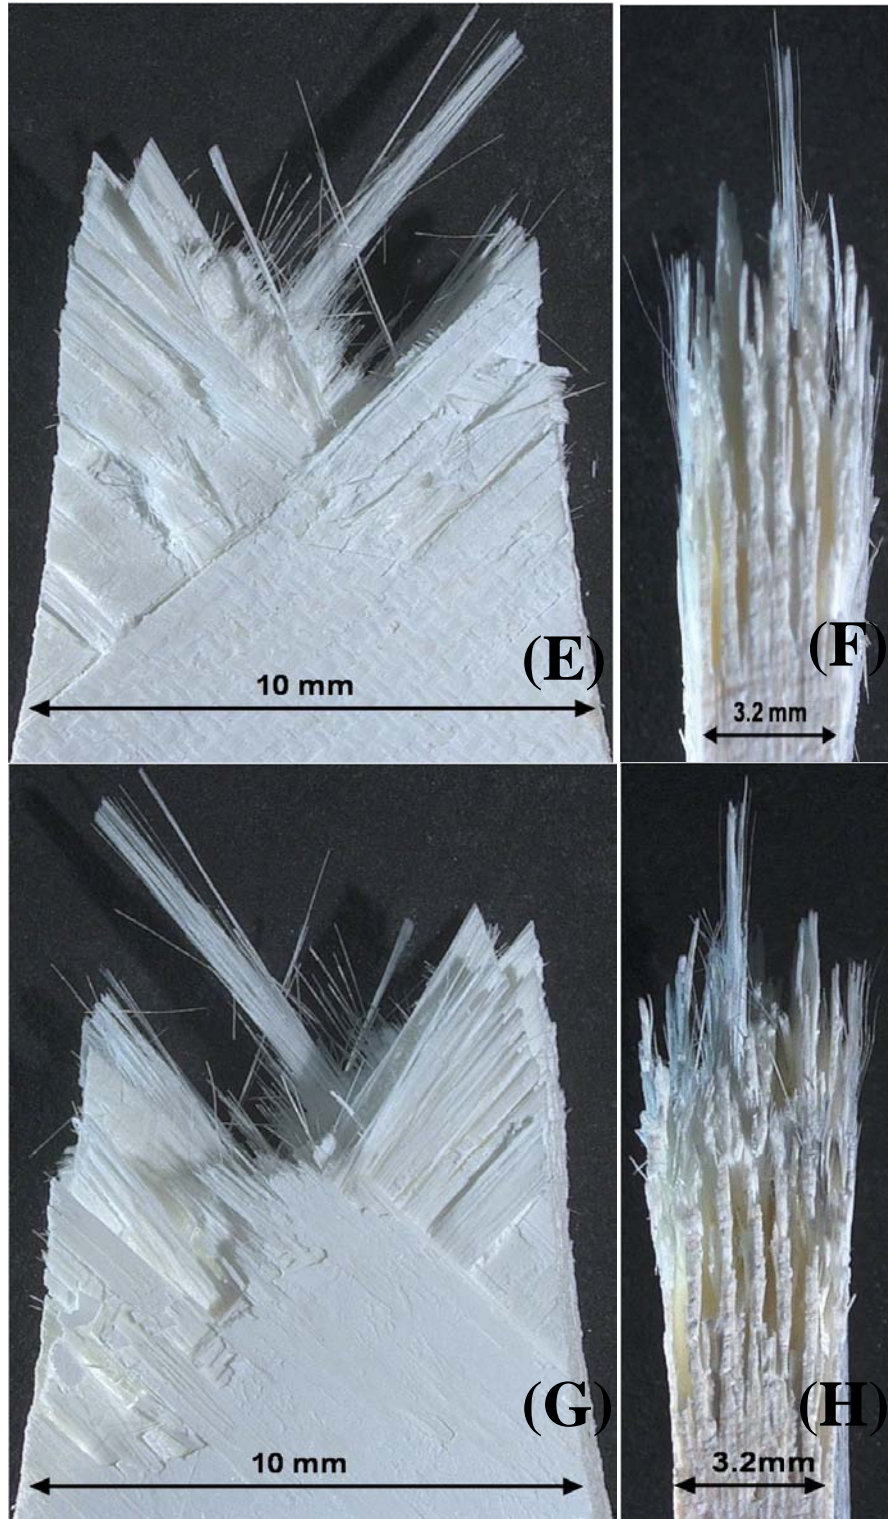
Figure 667. Fracture surface of the N720/AM specimen subjected to tensile test to failure following 100 h at 30 MPa at 1200°C in laboratory air.(e)-(g):front view,(f)-(h):side view

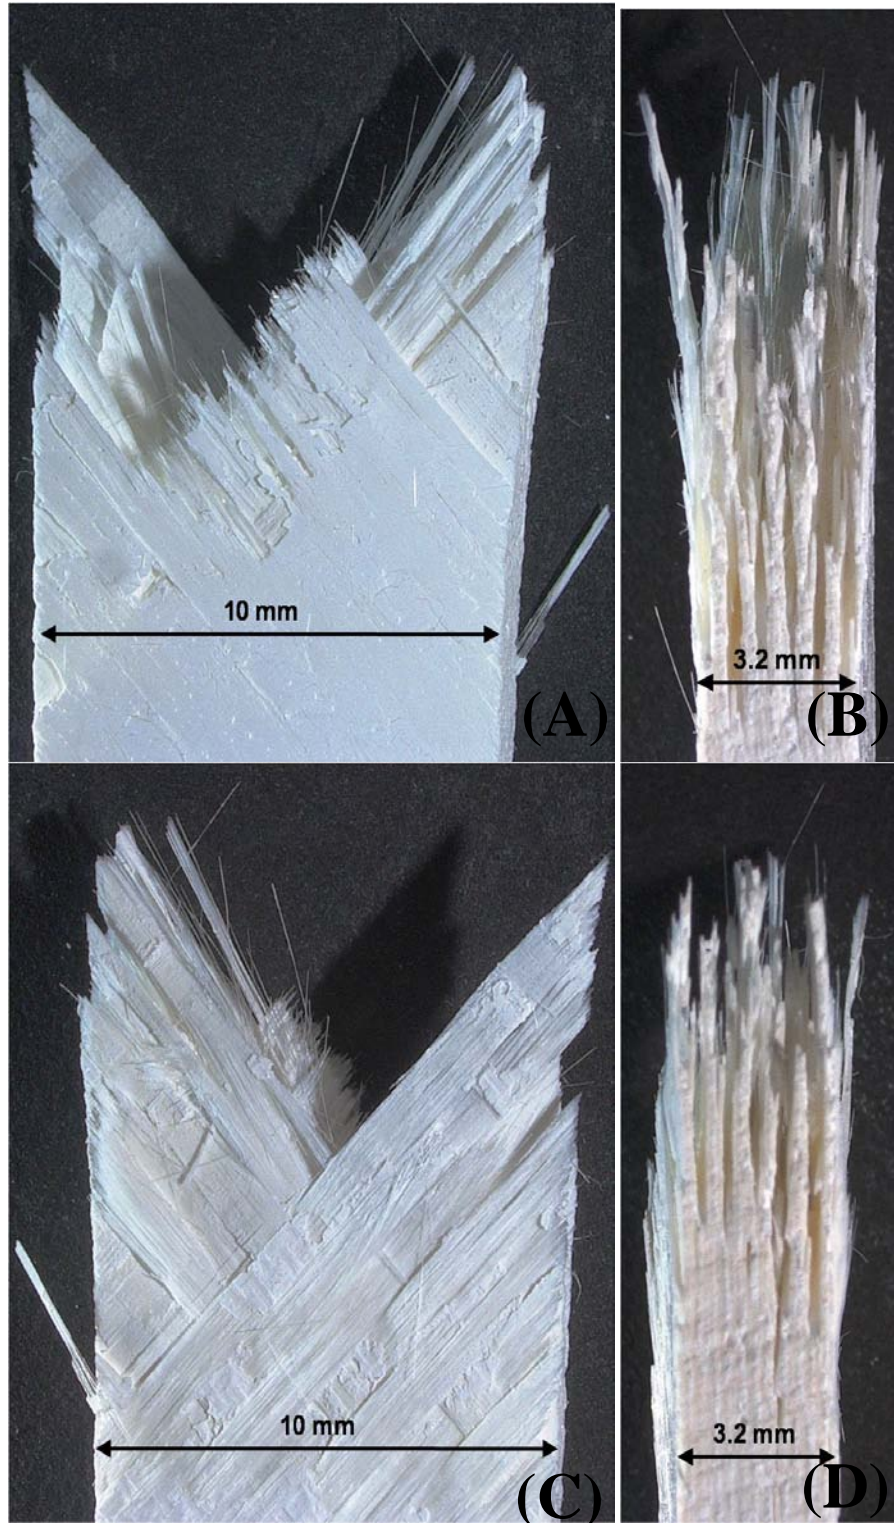
Figure 668. Fracture surface of the N720/AM specimen subjected to tensile test to failure following 100 h at 32 MPa at 1200°C in laboratory air.(a)-(c):front view,(b)-(d):side view

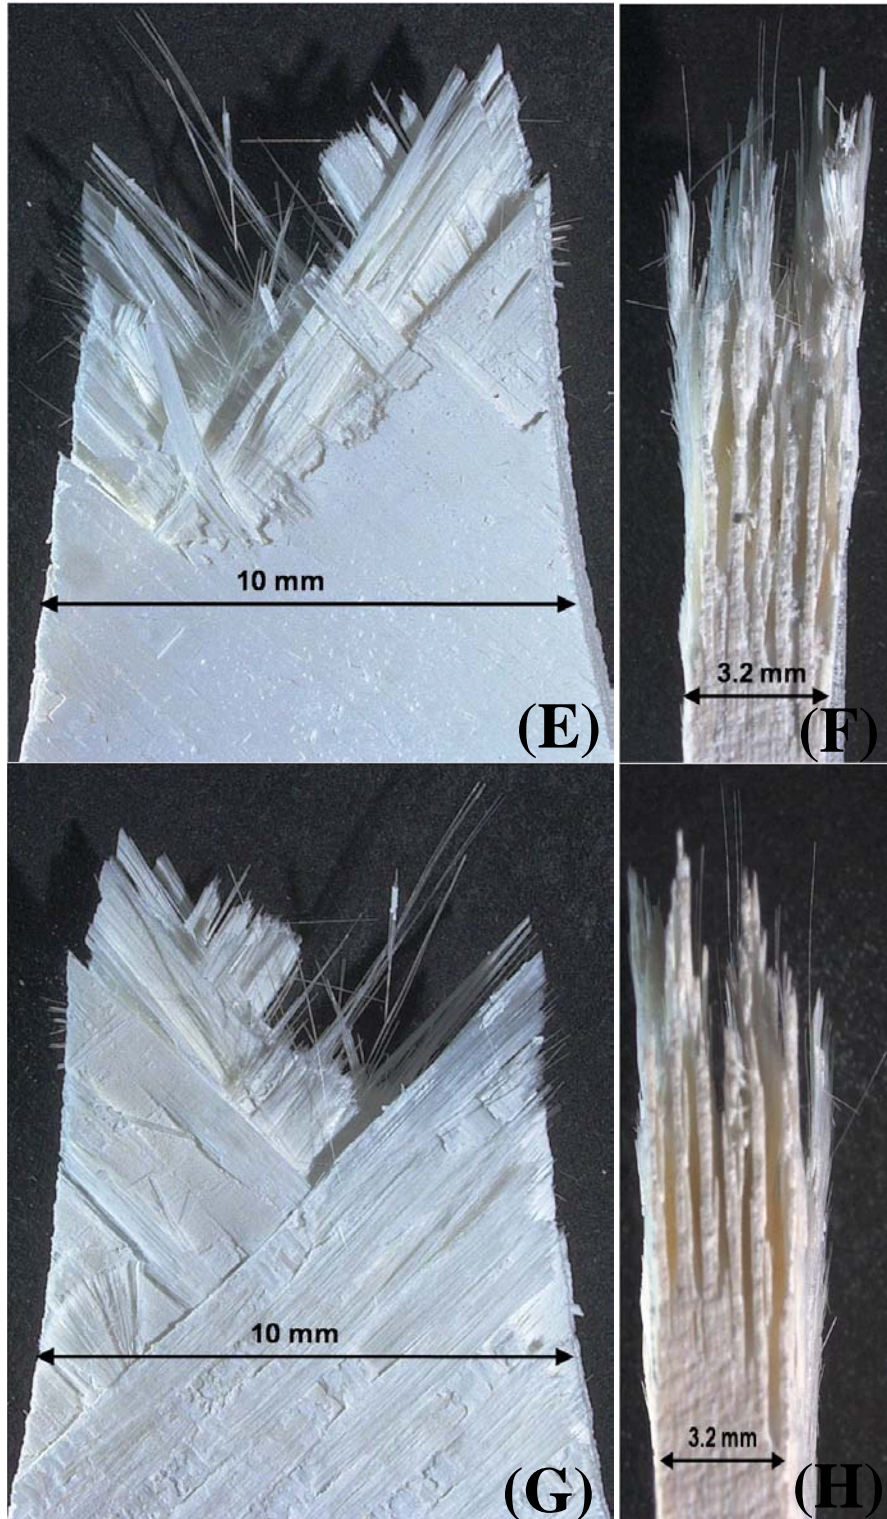
Figure 669. Fracture surface of the N720/AM specimen subjected to tensile test to failure following 100 h at 32 MPa at 1200°C in laboratory air.(e)-(g):front view,(f)-(h):side view

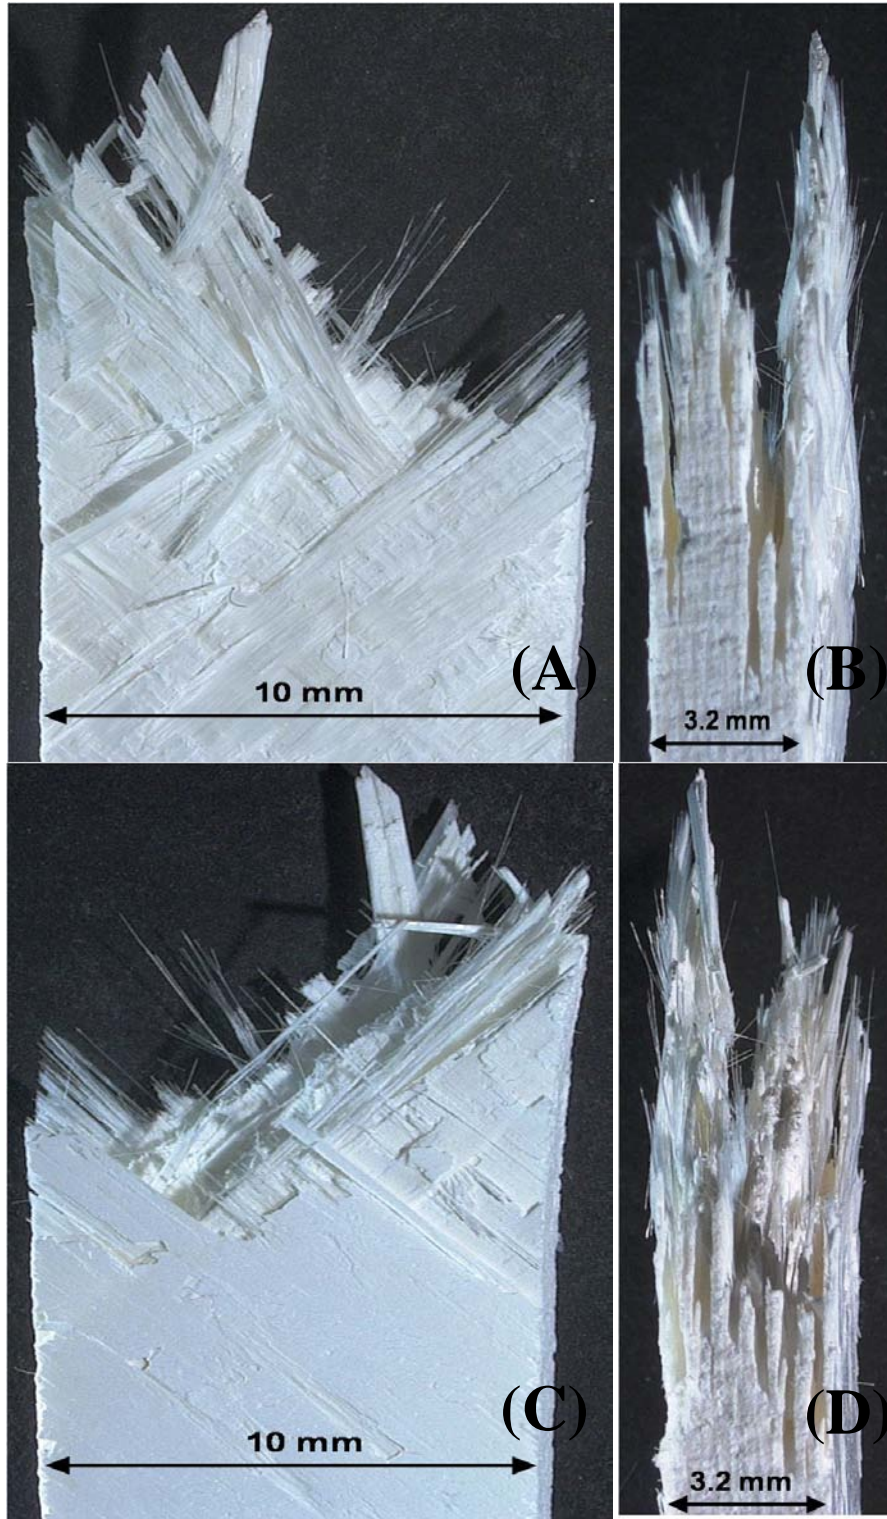
Figure 670. Fracture surface of the N720/AM specimen subjected to tensile test to failure following 100 h at 13 MPa at 1200°C in steam. (a)-(c): front view, (b)-(d): side view

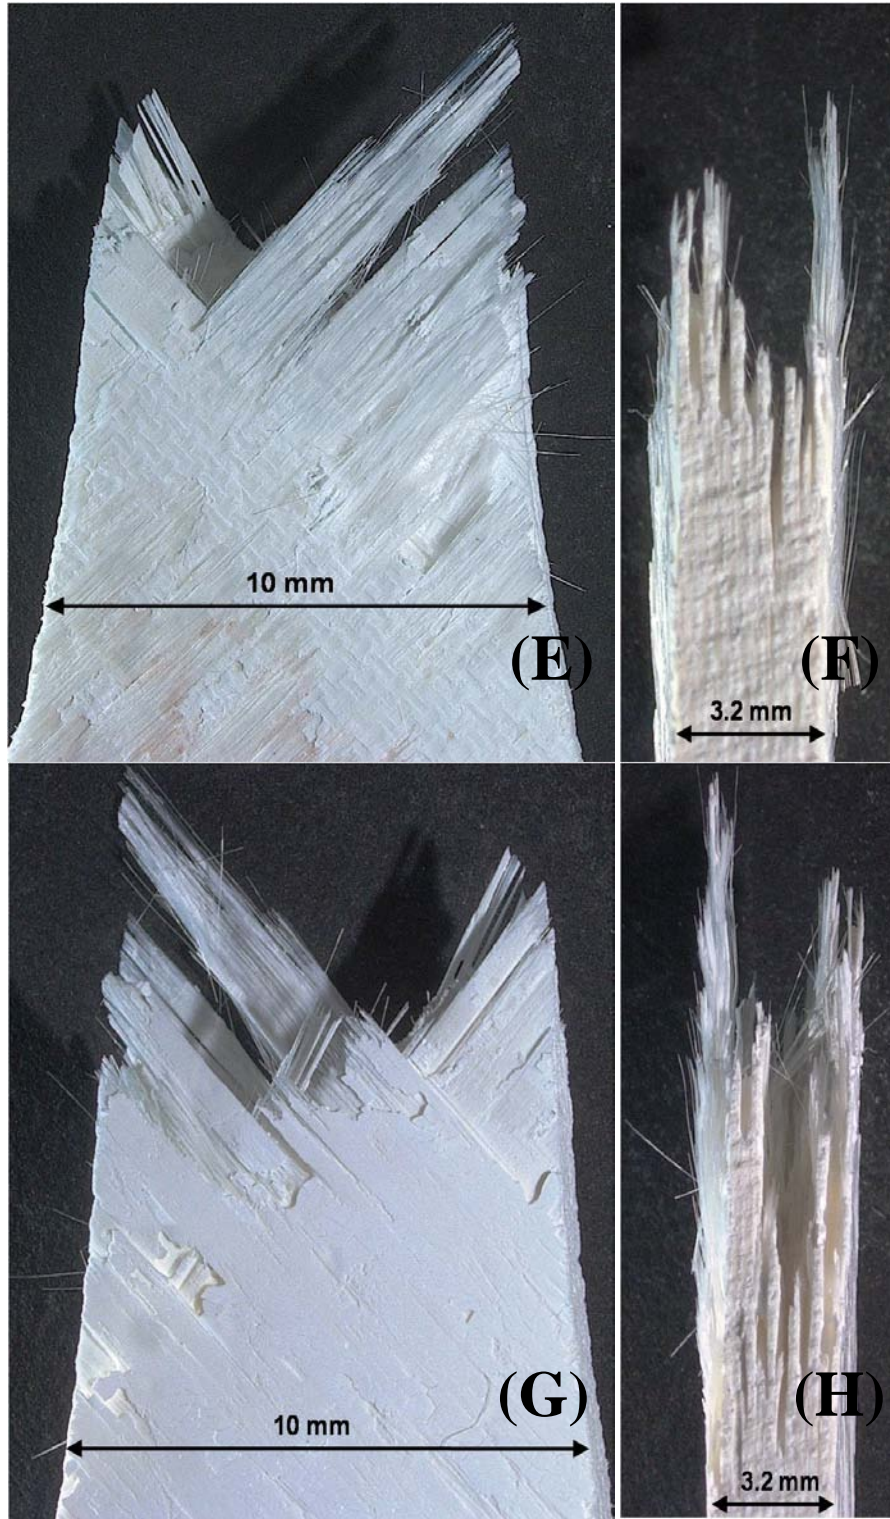
Figure 671. Fracture surface of the N720/AM specimen subjected to tensile test to failure following 100 h at 13 MPa at 1200°C in steam. (e)-(g): front view, (f)-(h): side view

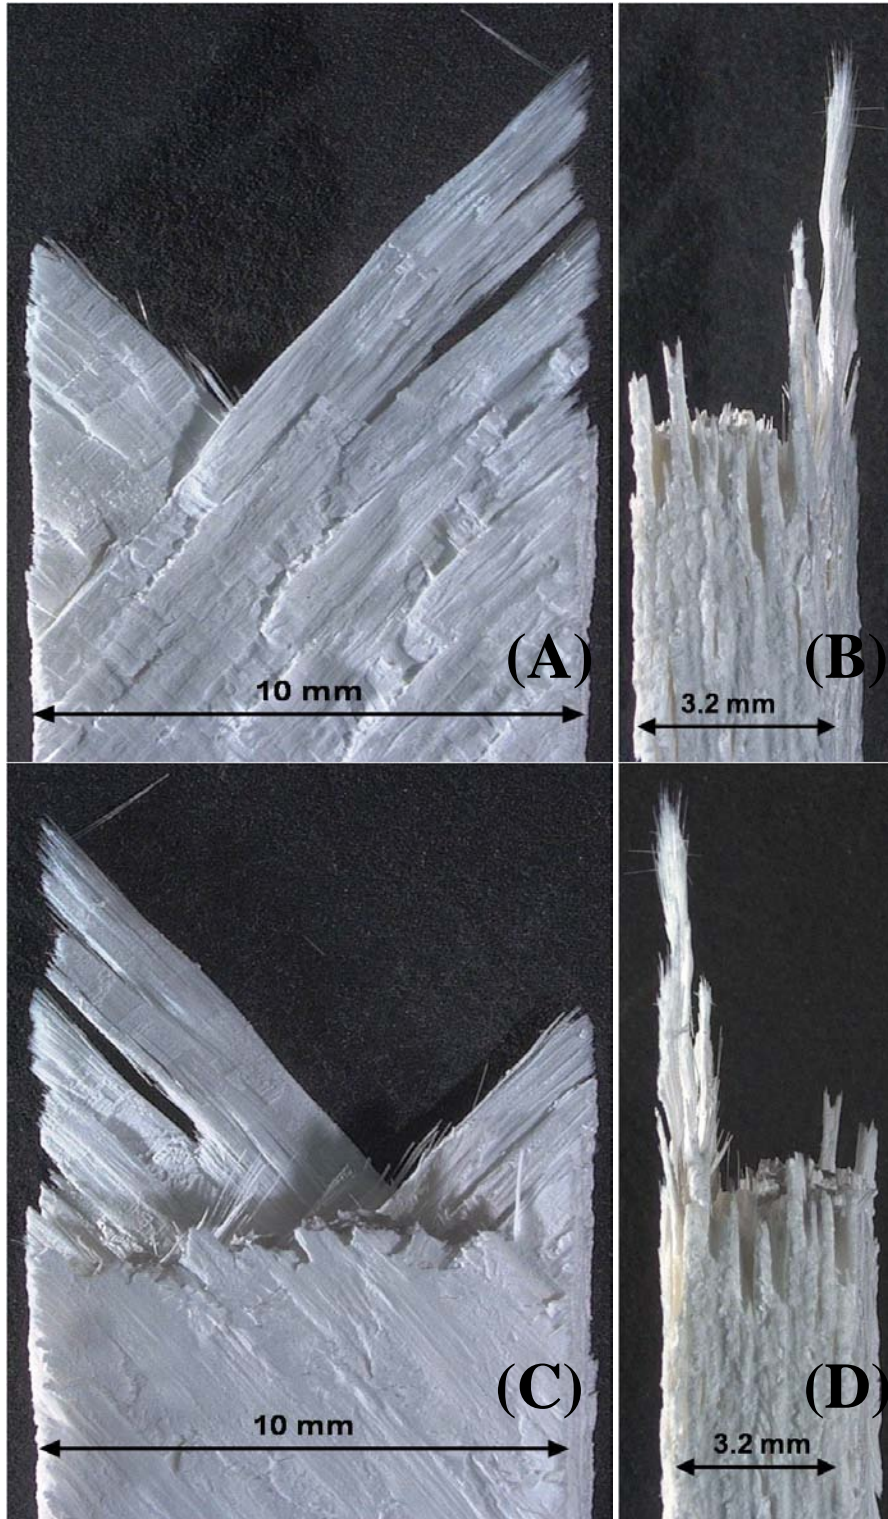
Figure 672. Fracture surface of the N720/AM specimen subjected to tensile test to failure following 100 h at 20 MPa at 1200°C in steam. (a)-(c): front view, (b)-(d): side view

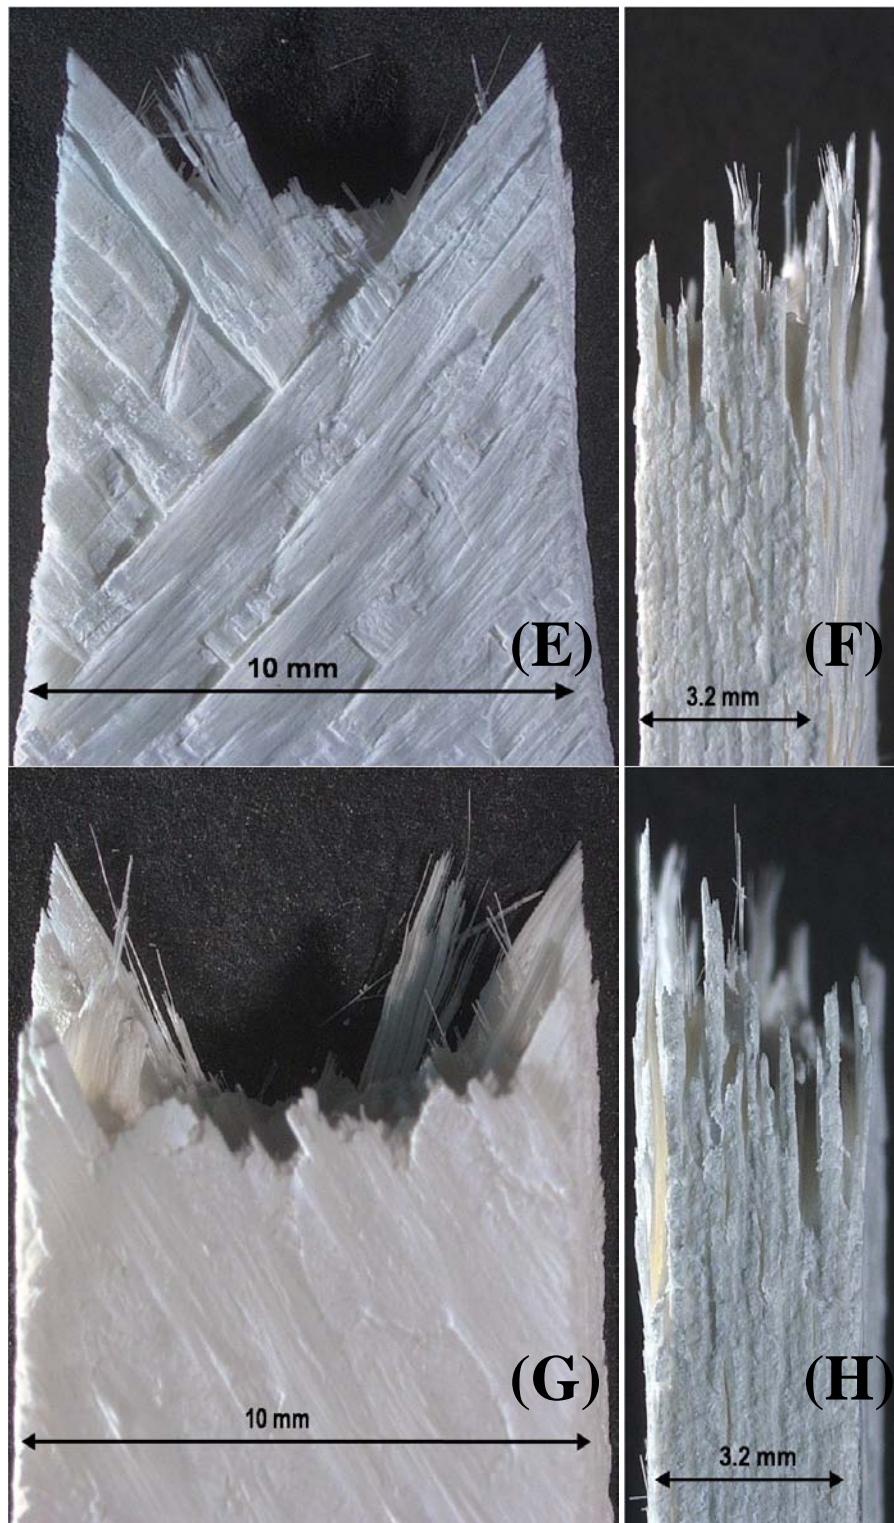
Figure 673. Fracture surface of the N720/AM specimen subjected to tensile test to failure following 100 h at 20 MPa at 1200°C in steam. (e)-(g): front view, (f)-(h): side view

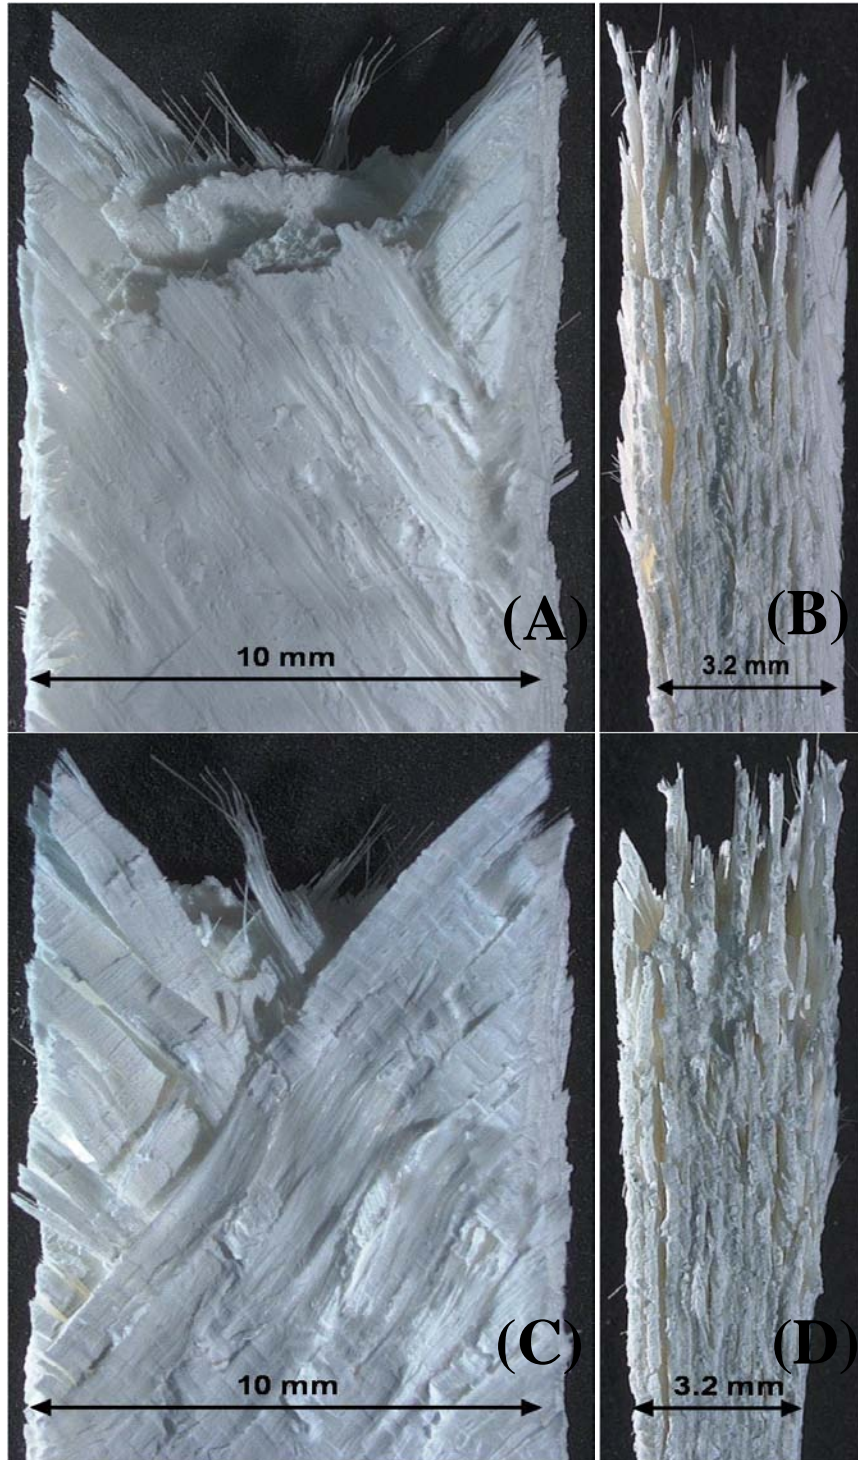
Figure 674. Fracture surface of the N720/AM specimen with $\pm 45^\circ$ fiber orientation obtained in creep test conducted at 26 MPa at 1200°C in steam. Creep lifetime $t_f = 99.4$ h.
 (a)-(c): front view, (b)-(d): side view

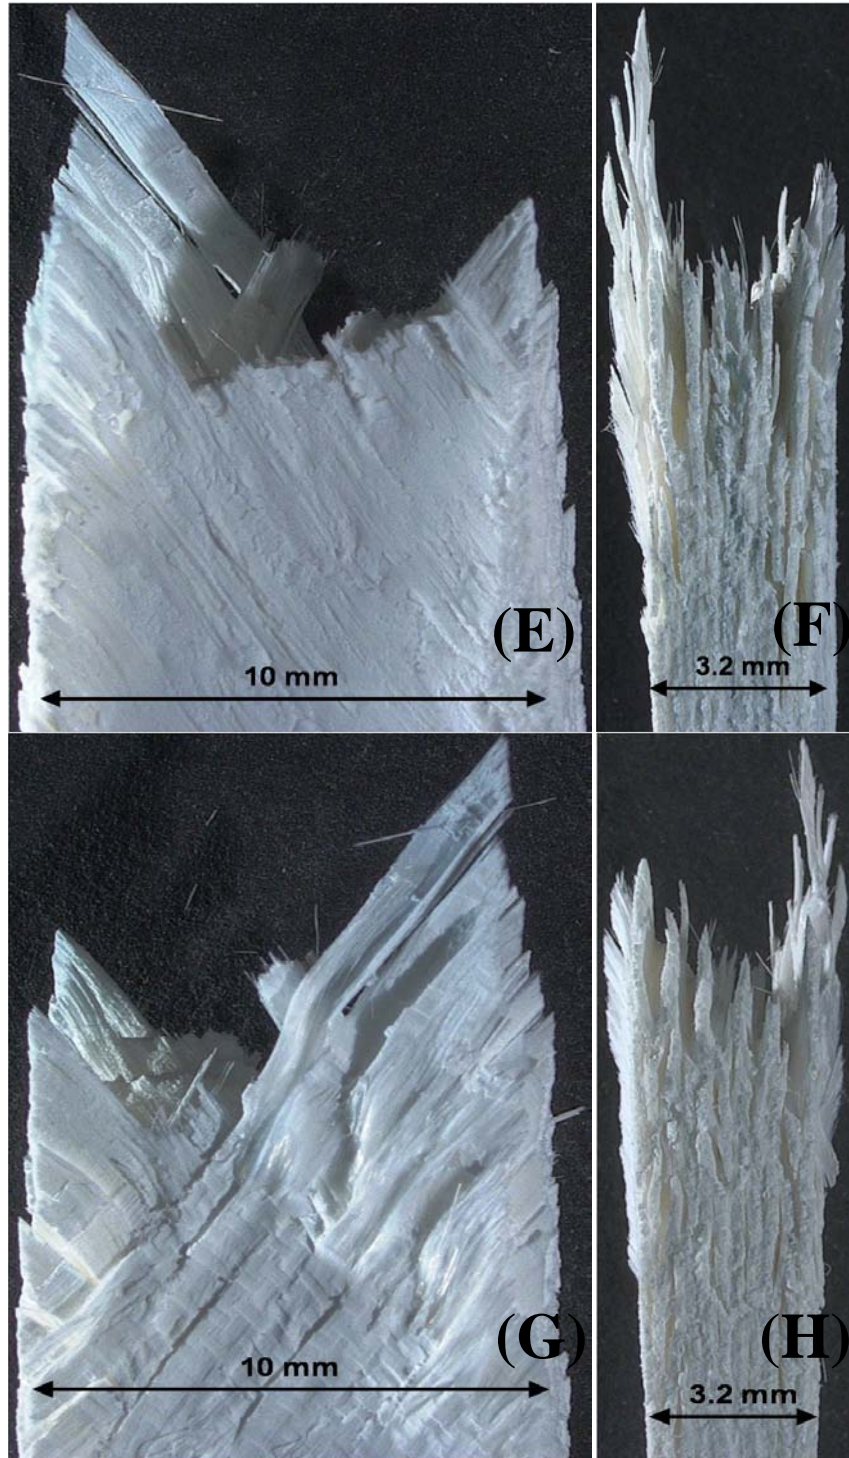
Figure 675. Fracture surface of the N720/AM specimen with $\pm 45^\circ$ fiber orientation obtained in creep test conducted at 26 MPa at 1200°C in steam. Creep lifetime $t_f = 99.4$ h.
 (e)-(g): front view, (f)-(h): side view

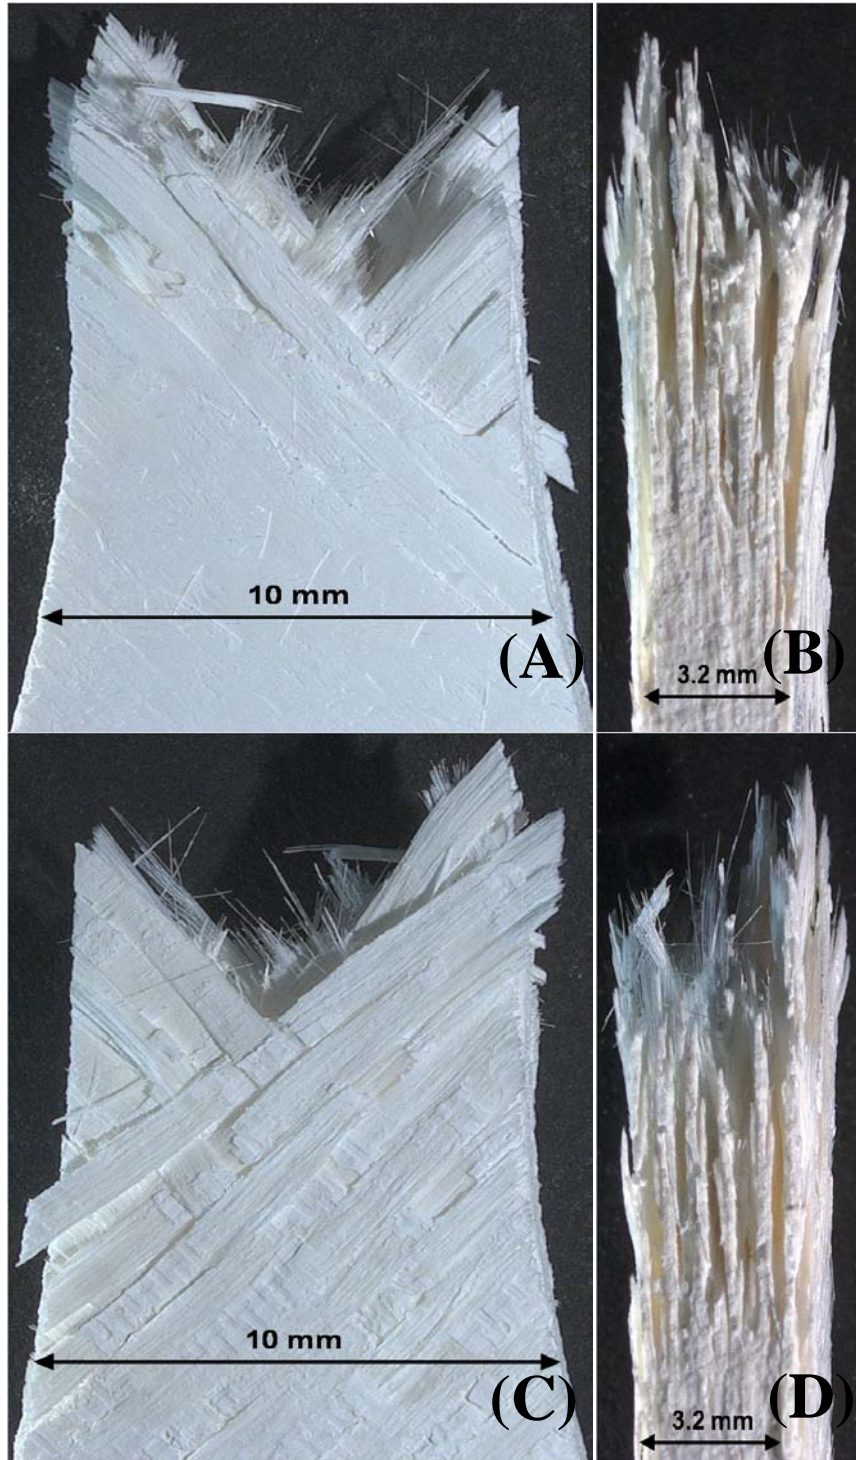
Figure 676. Fracture surface of the N720/AM specimen with $\pm 45^\circ$ fiber orientation obtained in creep test conducted at 30 MPa at 1200°C in steam. Creep lifetime $t_f = 1.08$ h.
 (a)-(c): front view, (b)-(d): side view

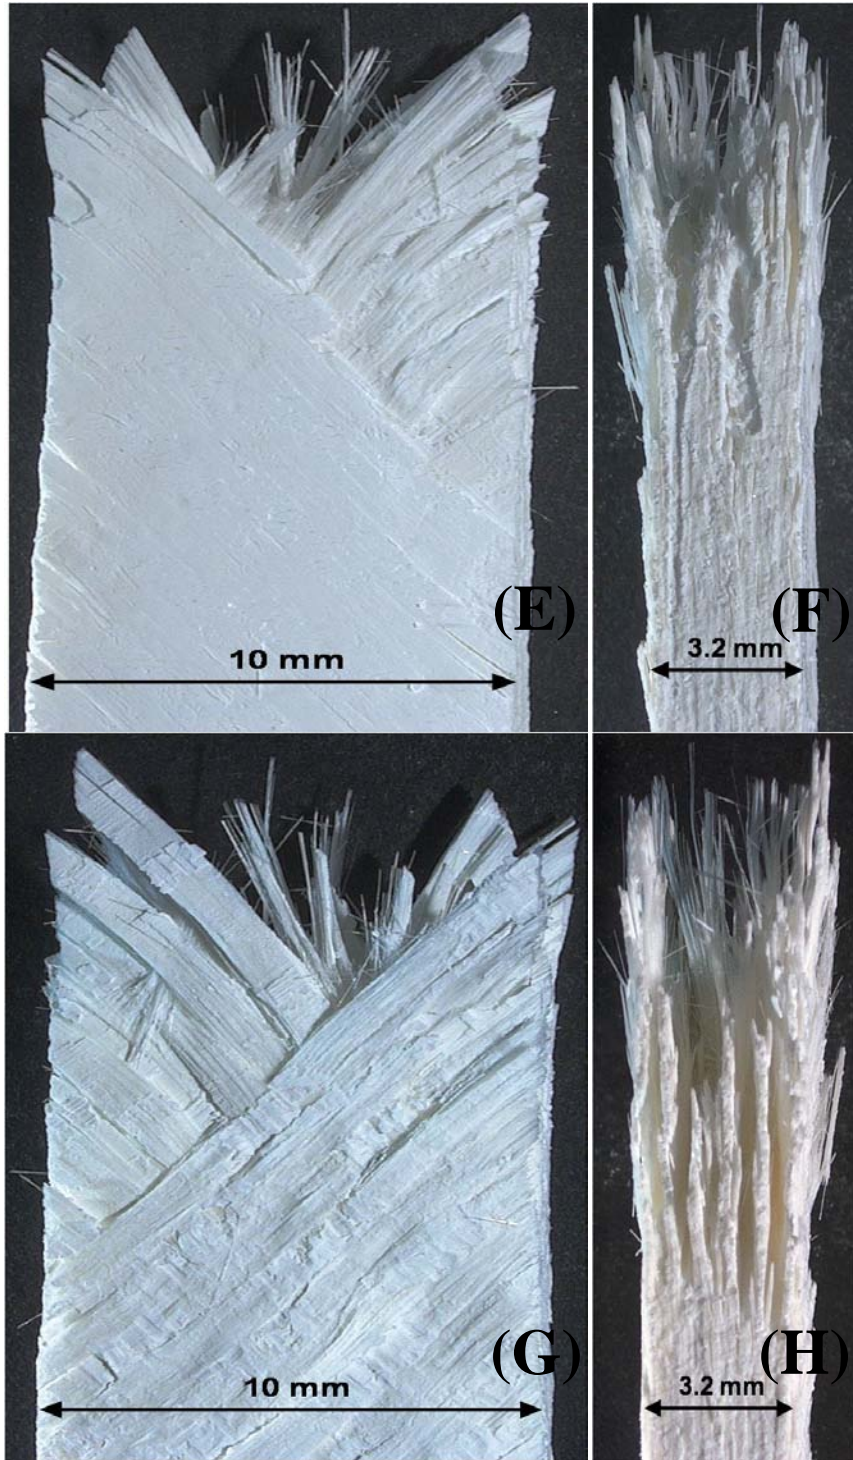
Figure 677. Fracture surface of the N720/AM specimen with $\pm 45^\circ$ fiber orientation obtained in creep test conducted at 30 MPa at 1200°C in steam. Creep lifetime $t_f = 1.08$ h.
(e)-(g): front view, (f)-(h): side view

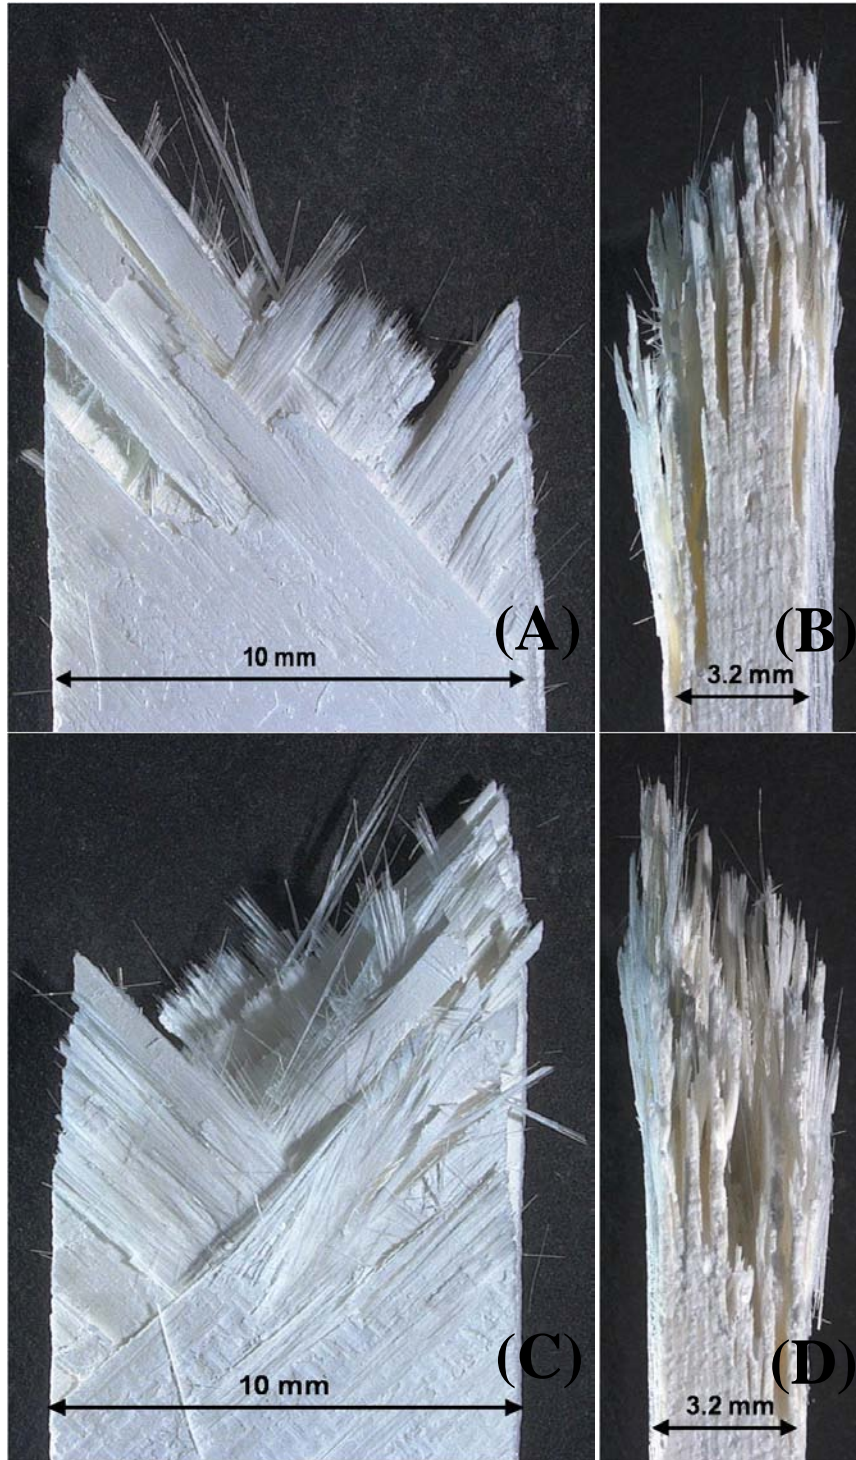
Figure 678. Fracture surface of the N720/AM specimen with $\pm 45^\circ$ fiber orientation obtained in creep test conducted at 32 MPa at 1200°C in steam. Creep lifetime $t_f = 0.02$ h.
 (a)-(c): front view, (b)-(d): side view

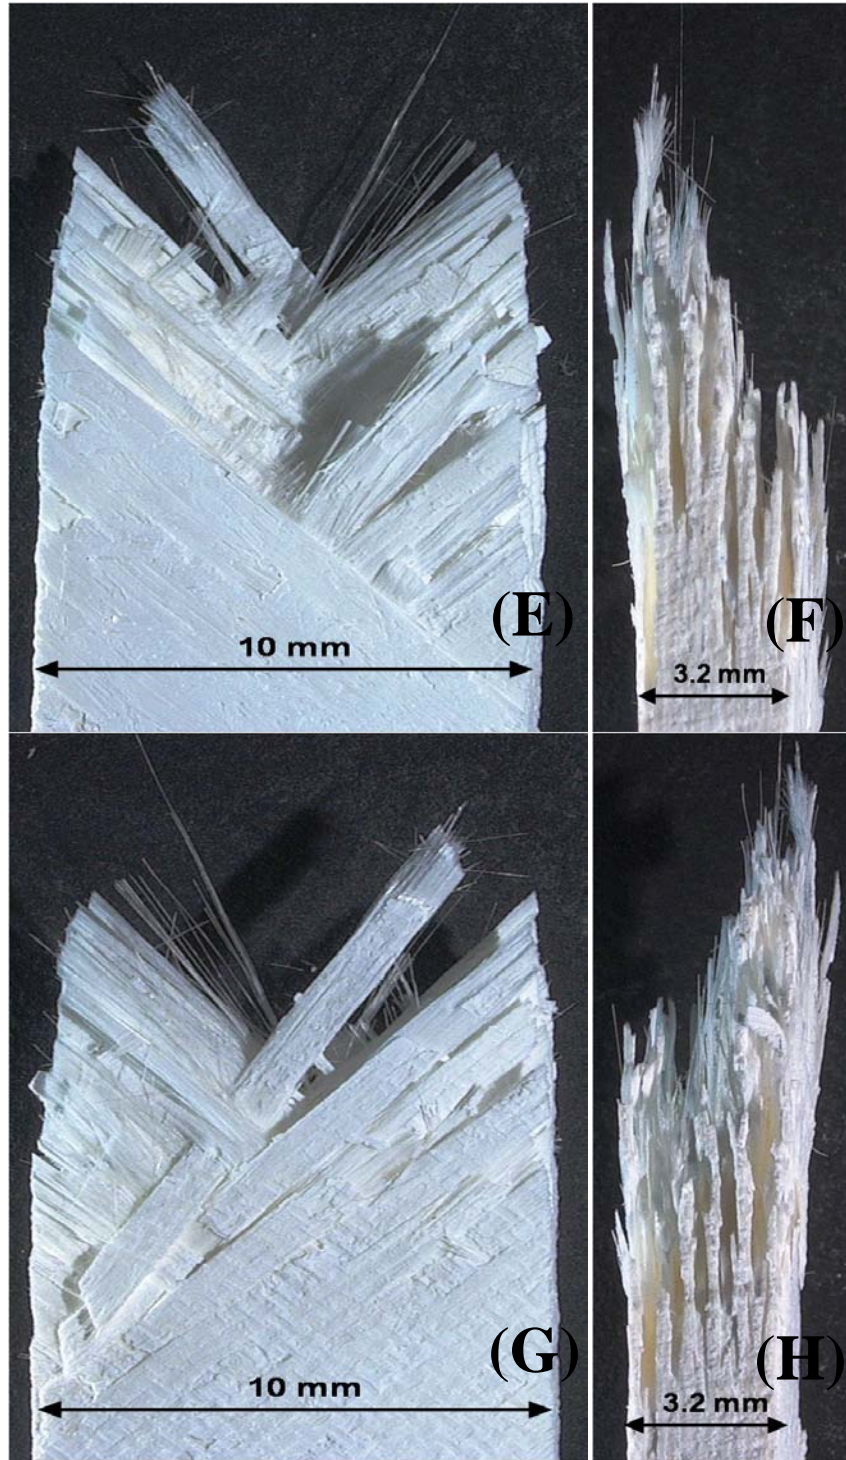
Figure 679. Fracture surface of the N720/AM specimen with $\pm 45^\circ$ fiber orientation obtained in creep test conducted at 32 MPa at 1200°C in steam. Creep lifetime $t_f = 0.02$ h.
 (e)-(g): front view, (f)-(h): side view

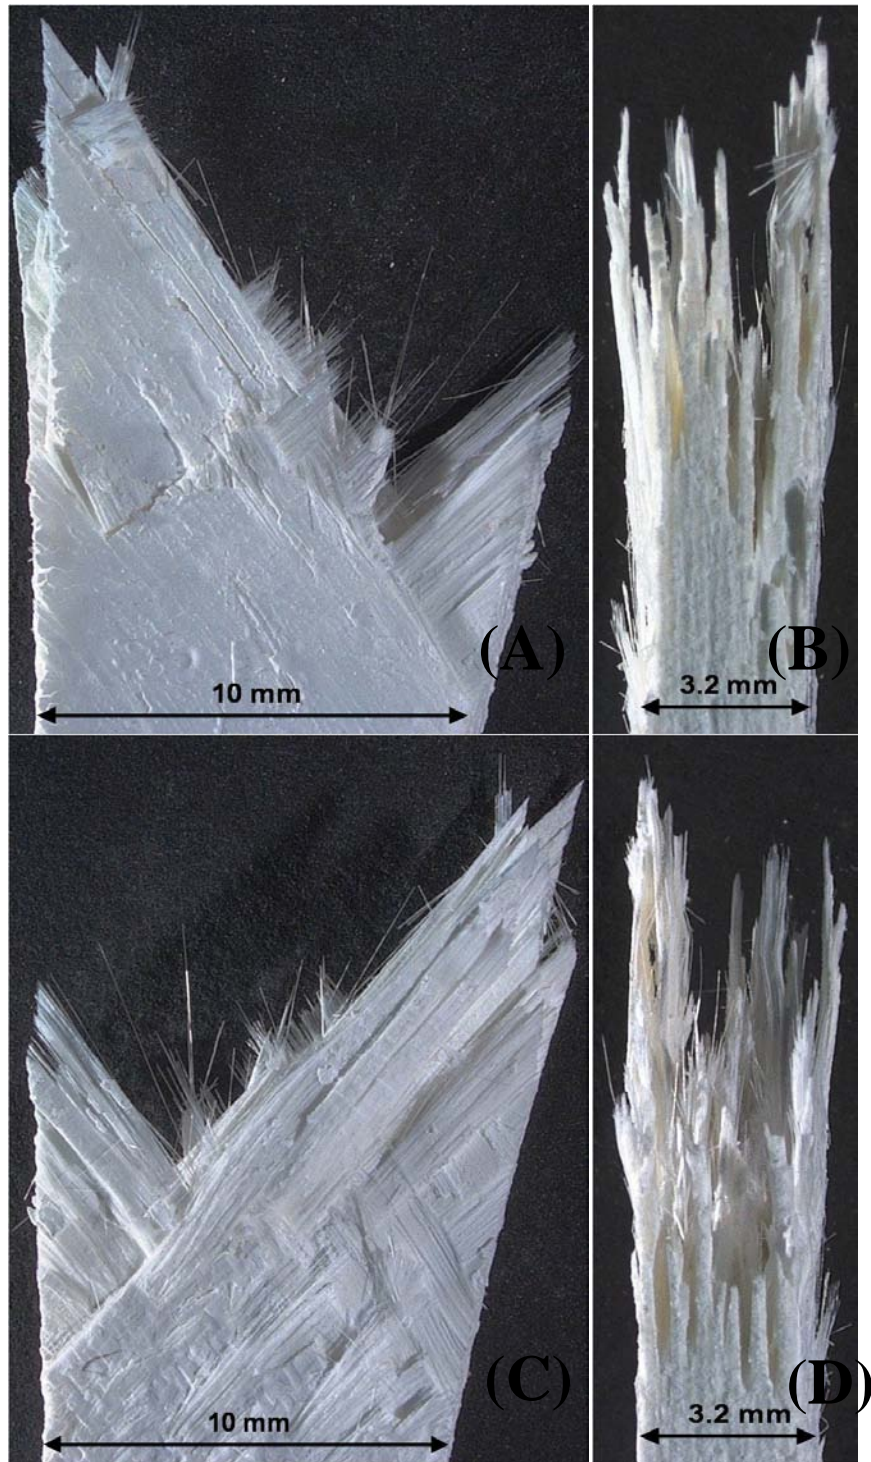
Figure 680. Fracture surface of the N720/AM specimen subjected to tensile test to failure following 100 h at 20 MPa at 1200°C in argon. (a)-(c): front view, (b)-(d): side view

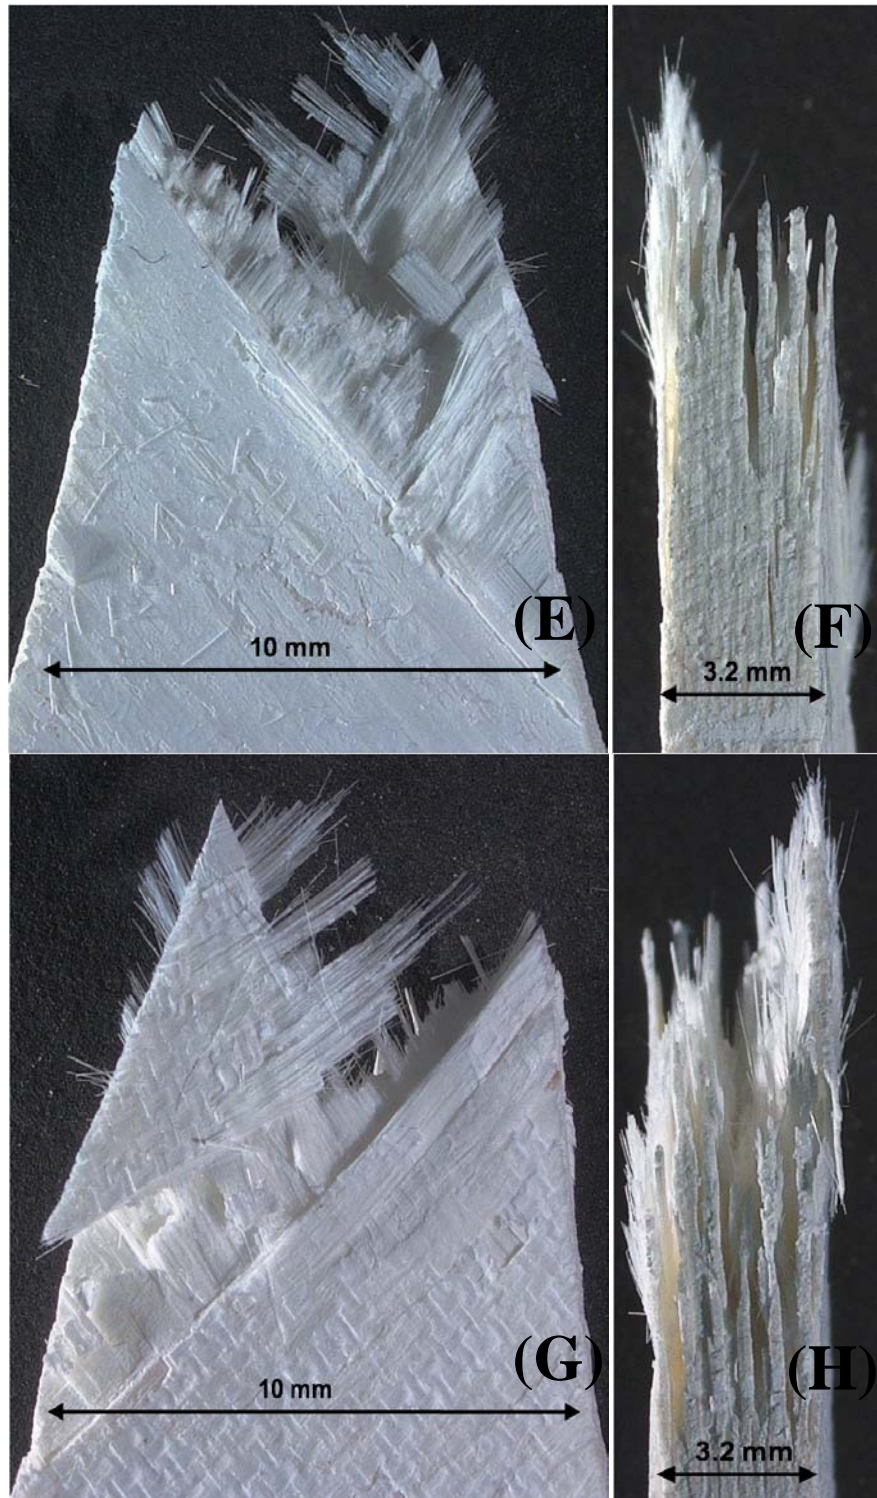
Figure 681. Fracture surface of the N720/AM specimen subjected to tensile test to failure following 100 h at 20 MPa at 1200°C in argon. (e)-(g): front view, (f)-(h): side view

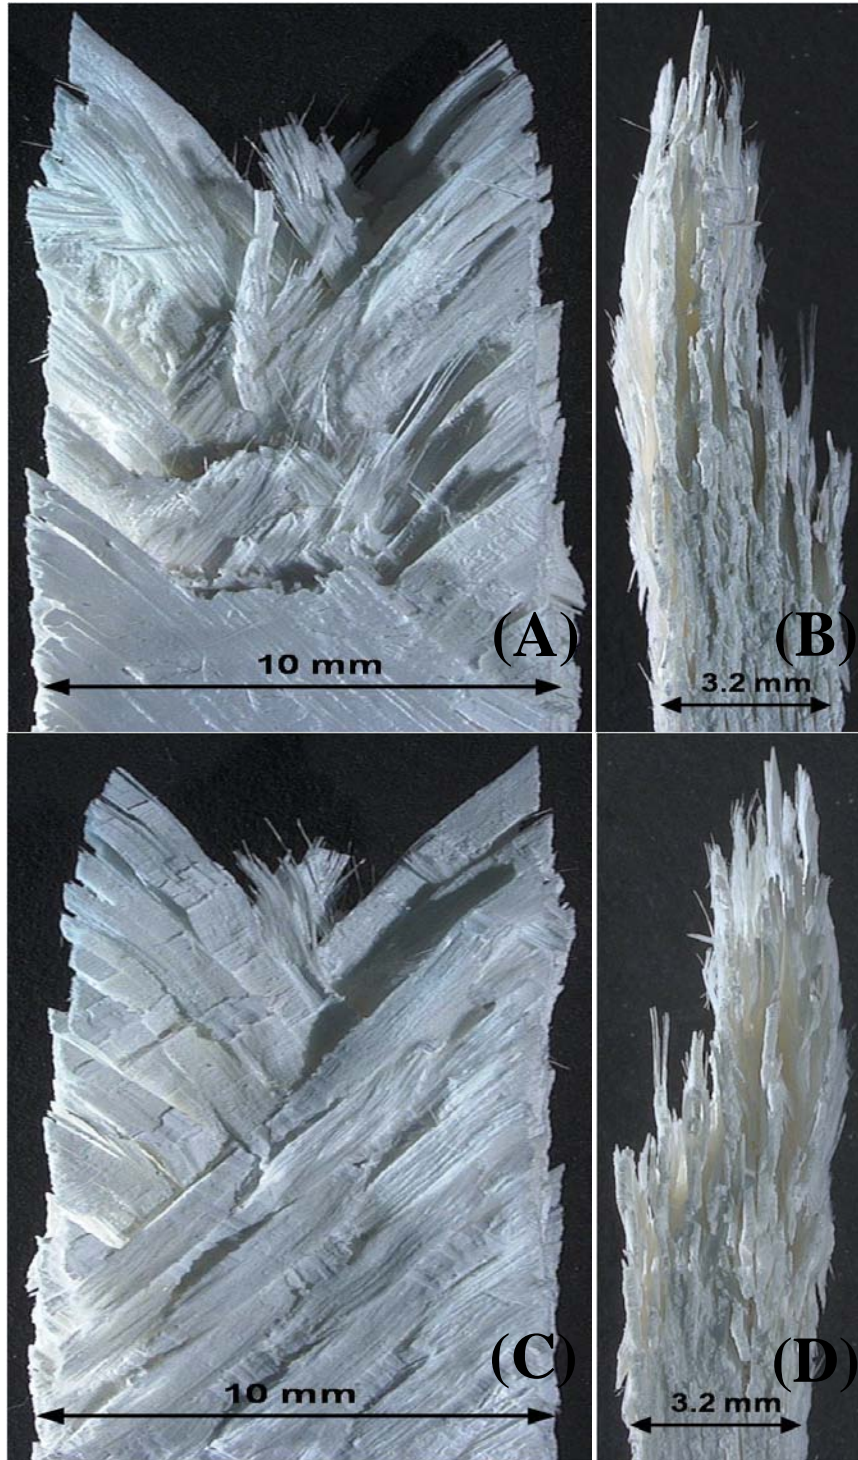
Figure 682. Fracture surface of the N720/AM specimen with $\pm 45^\circ$ fiber orientation obtained in creep test conducted at 26 MPa at 1200°C in argon. Creep lifetime $t_f = 76$ h.
 (a)-(c): front view, (b)-(d): side view

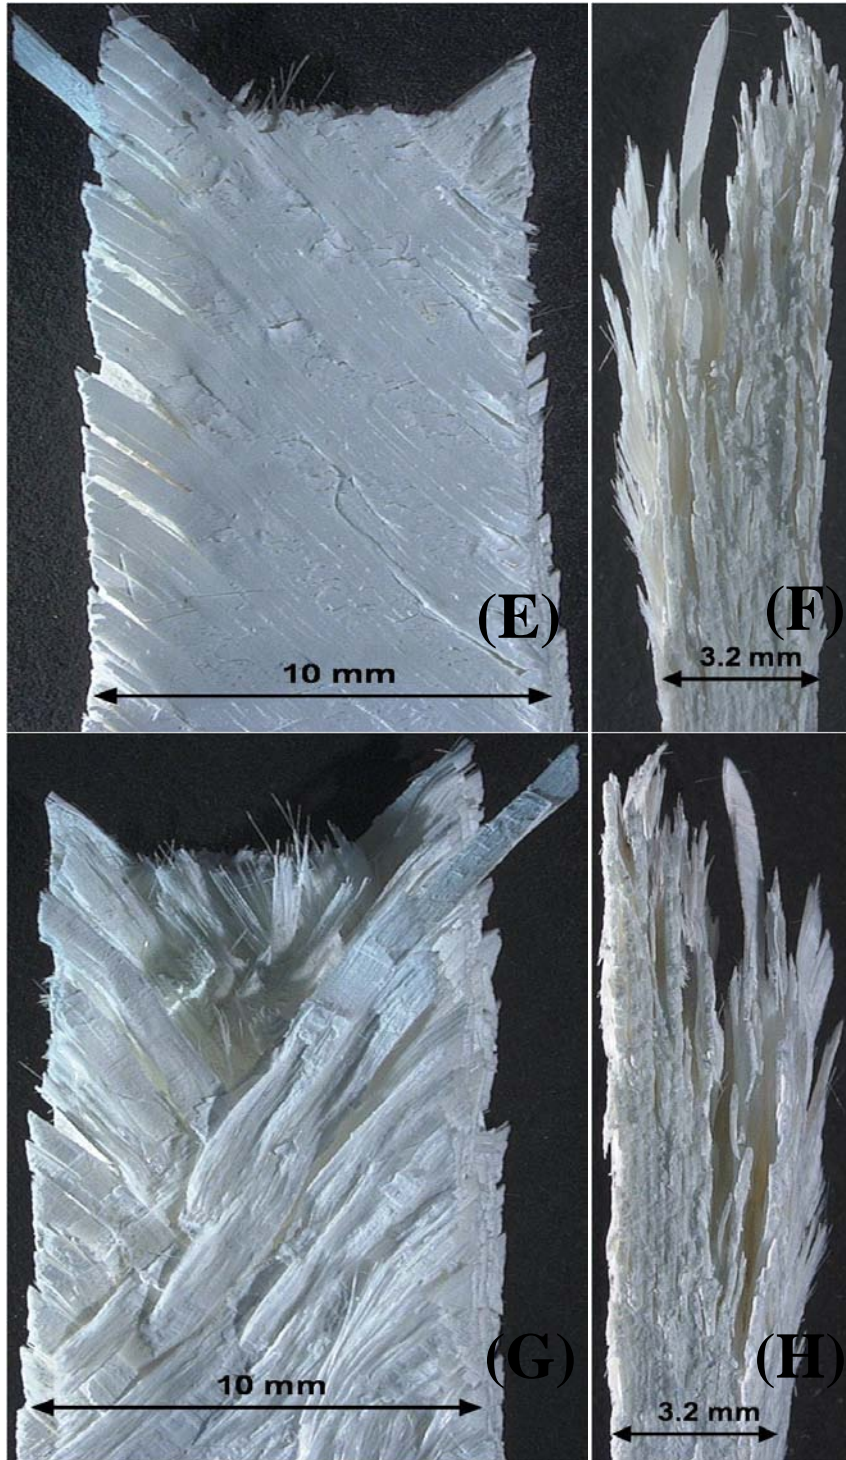
Figure 683. Fracture surface of the N720/AM specimen with $\pm 45^\circ$ fiber orientation obtained in creep test conducted at 26 MPa at 1200°C in argon. Creep lifetime $t_f = 76$ h.
 (e)-(g): front view, (f)-(h): side view
